270 VOLT DC VARIABLE SPEED
GENERATOR AND CONTROL UNIT,
AIRCRAFT ELECTRICAL POWER SYSTEM

September 18, 1980

FINAL TECHNICAL REPORT

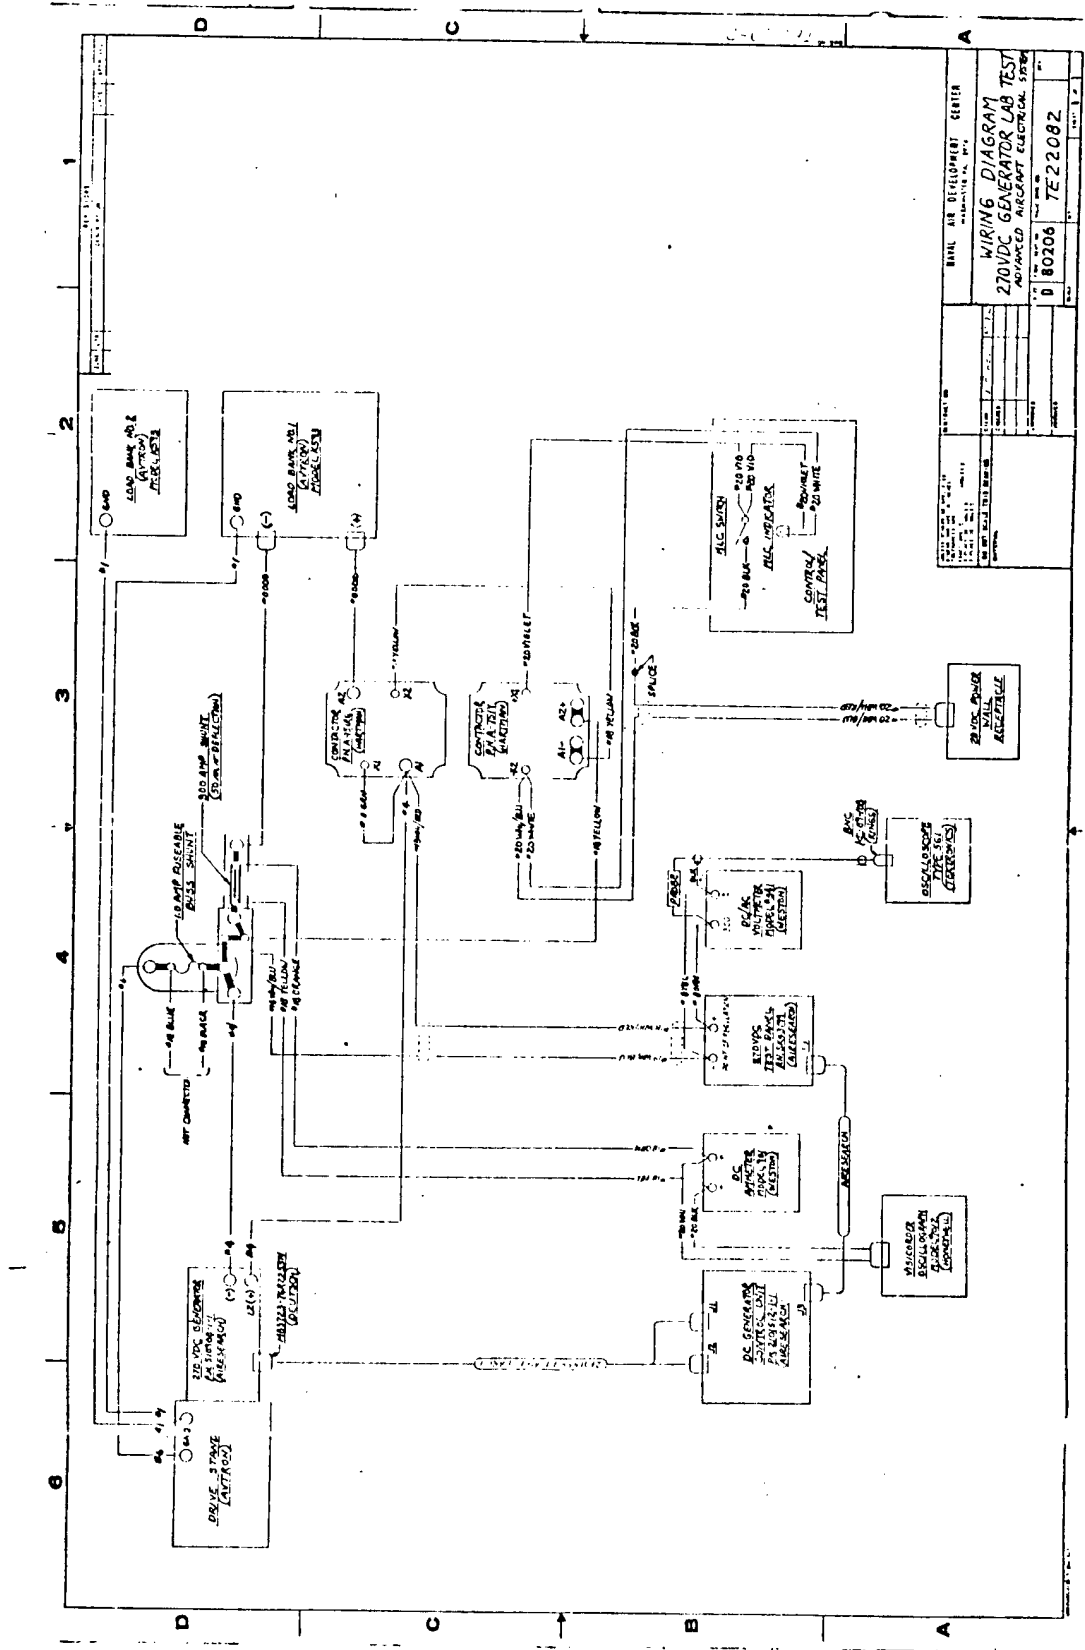
1. A wiring diagram of the 270 volt DC system interconnection and instrumentation is shown on Figure 1 (Wiring Diagram, 270 VDC Generator Lab Test, NADC Drawing No. TE22082).
2. Additional instrumentation, not shown on Figure 1, consisted of thermocouple temperature monitoring of coolant temperature into the generator, coolant temperature out of the generator, and one generator bearing temperature. The generator had four thermocouples, but the only one operative was the one from the top of the generator rear manifold cover.
3. Closed circuit television camera monitoring and recording was also provided.
